Rotor Straightening

Product Sheet

On-Site or Shop Solution

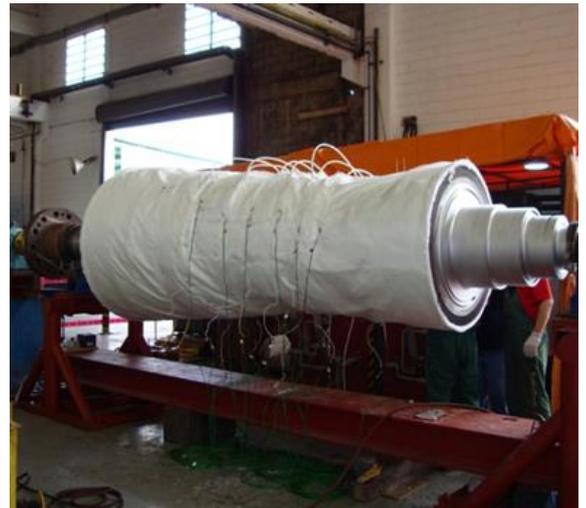
The turbine rotor shaft straightening process has been used to successfully straighten over 100 rotors of various structures and power values. On the average, a distortion found manifests in 0.00-0.5mm distortion, however case have been seen with a distortion value reaching 7.0mm on a generator rotor distorted due to a failure and 5.4mm on a high pressure shaft of a 10 MW turbine. In one case, distortion of one shaft had occurred in several places, requiring the straightening process to be performed on each distortion separately.

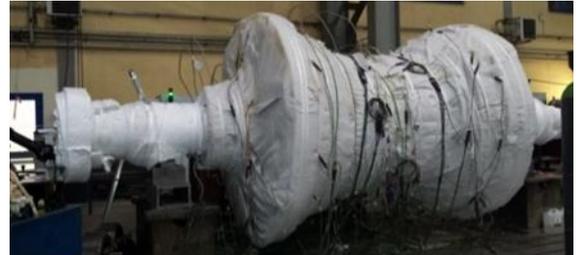
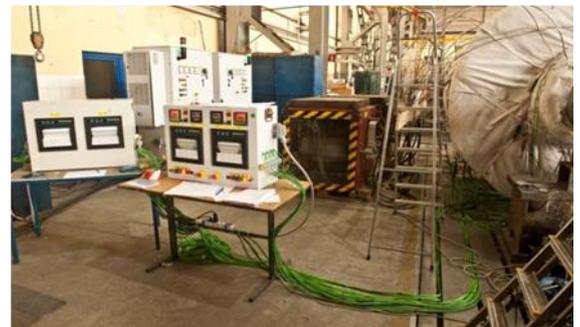
Prior to beginning turbine rotor shaft straightening, a detailed evaluation of the rotor condition and working out the entire repair scope is necessary. Additionally, prior to starting straightening is to perform defectoscopic studies to ensure there are no cracks or material discontinuity. Finally, curvature measurements and distortion reason analysis are conducted to choose the most appropriate course of action. A rotor to be straightened is set on a special straightening stand which enables technicians to take curvature measurements, to install a temperature measuring system, to produce thermal insulation and to install a heating system, as well as to induce loadings needed in straightening. This stand is made in a portable form, which allows the straightening to be performed on-site. The straightening process is completed in two stages and four cycles. The first stage is to remove stresses from the shaft material at the distortion spot, while the second stage consists of straightening of the plastic distortion. Straightening of a typical turbine shaft is completed, typically, when run out does not exceed 0.12mm (axis distortion 0.06mm). After straightening, the rotor must be balanced dynamically prior to returning to service. Typical straightening of a rotor shaft of 0.5mm distortion takes approximately 5 days when a prepared stand is used.
